GERMAN SELF-PROPELLED GUNS

**Self-propelled artillery
anti-tank and anti-aircraft guns**

Gordon Rottman

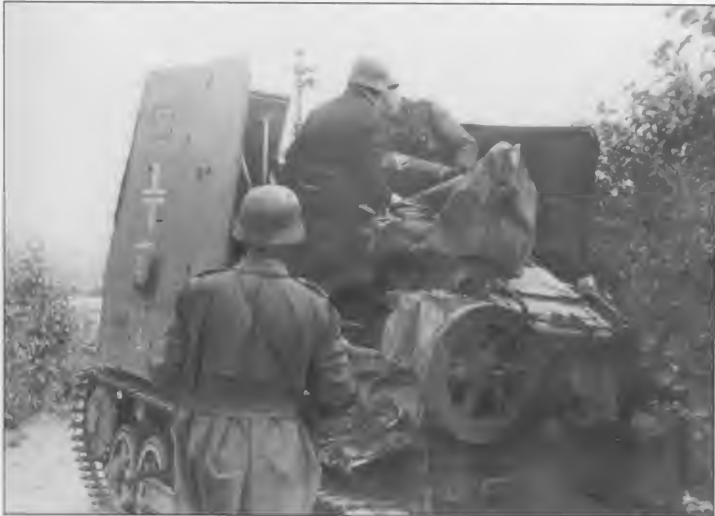
One of the earliest self-propelled artillery pieces was the 15cm s.I.G.33/1 (Sf.) auf Pz.Kpfw.I Ausf.B or 'Bison' I (Sd.Kfz.101). The boxy 10mm thick superstructure was extremely high (3.5 meters) and gun added 6,000 pounds (2,700 kilograms) resulting in a top-heavy vehicle with poor cross-country mobility. It had a five-man crew, two of whom rode in an accompanying Sd.Kfz.10 half-track carrying extra ammunition. Ammunition was carried in the support vehicle as only three ready rounds could be carried aboard the 'Bison'. The 15cm s.I.G.33/1 infantry gun was mounted on a Pz.Kpfw.I Ausf.B tank chassis on its normal carriage. Only 38 of these vehicles were converted in early 1940 and employed with infantry gun companies (Infanterie-Geschütz-Kompanie) in France, Russia, and the Balkans until withdrawn in late 1943. These companies were normally attached to Panzer divisions. This 'Bison' I displays four insignia on its dark gray side (from top to bottom):- narrow white outline Balkenkreuz (no black), white "5" for the gun number, dark yellow 1.Panzer-Division insignia (inverted Y), and a white tactical unit symbol. Soviet Union, August 1941.

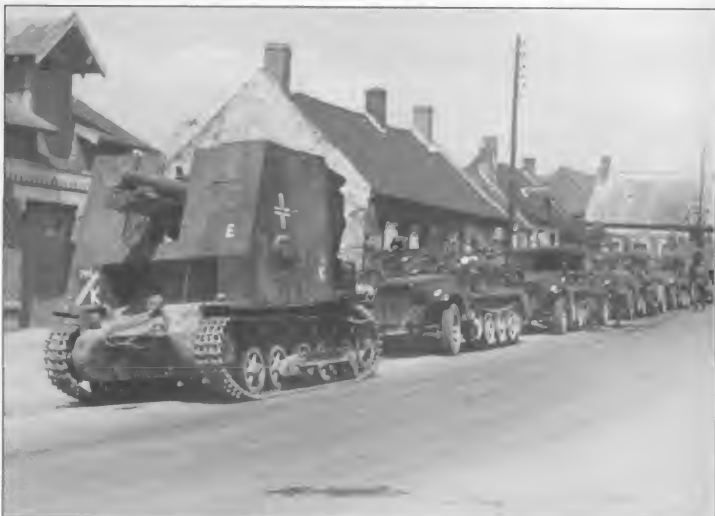
A 'Bison' I awaits order to move further into a French town, 1940. This 706.Infanterie-Geschütz-Kompanie 'Bison' is painted dark gray. The white "K" identifies it as belonging to Panzergruppe von Kleist (later redesignated Panzergruppe 1). The white "E" indicates it is the fifth gun within the battery. The guns were identified A through F. Note the tunnel-like recessed opening beneath the gun. This provided the driver with a field of vision and allowed for an overhang of the gun compartment to provide much needed room for the crew and gun. Unarmored Sd.Kfz.10 personnel carrier halftracks are lined up behind the 'Bison' with another 'Bison' bringing up the rear.

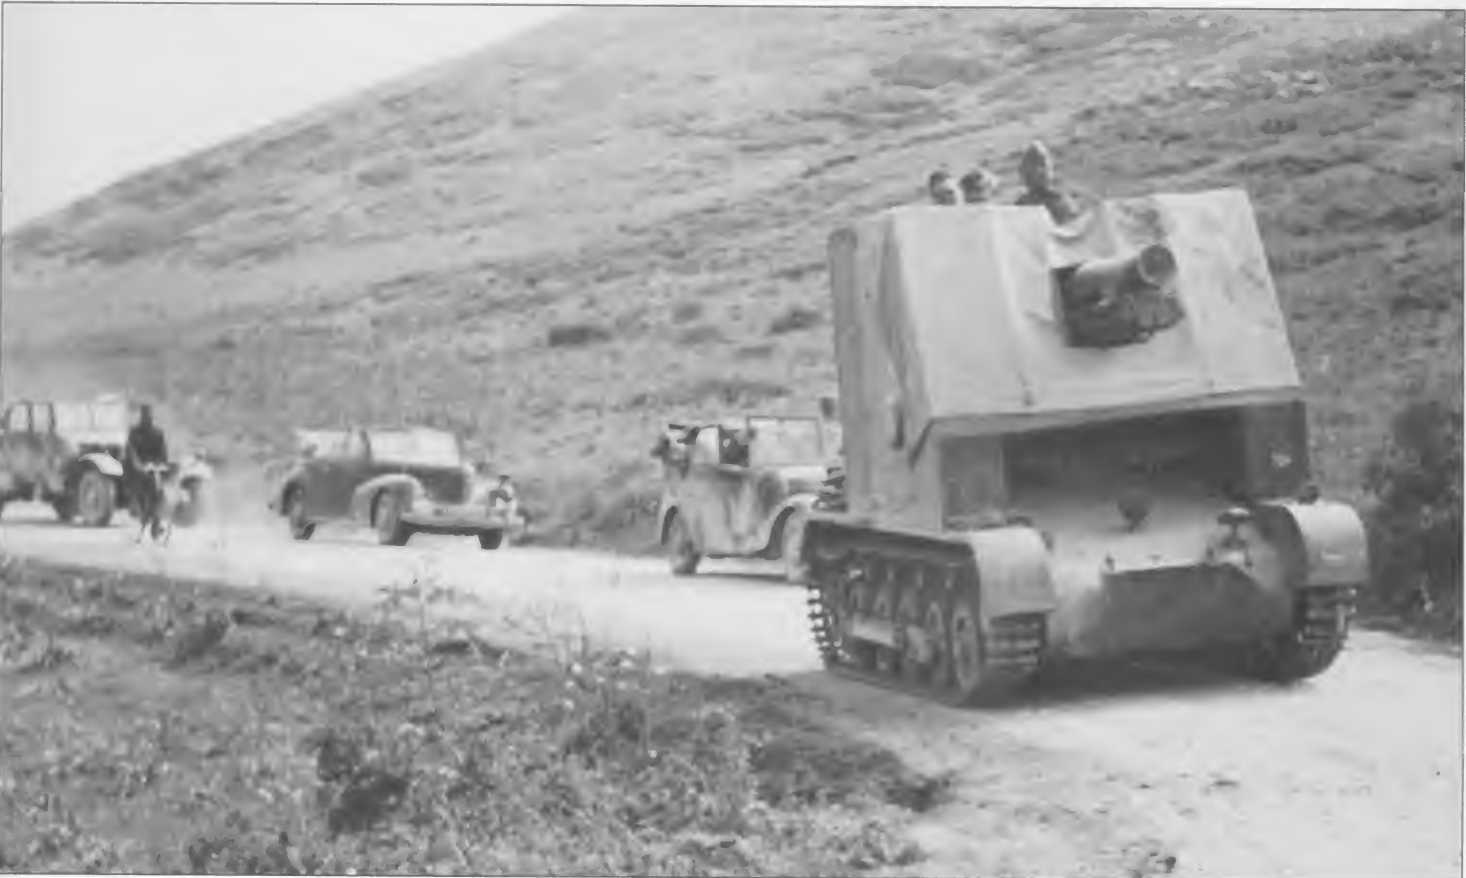
A 'Bison' I of 704.Infanterie-Geschütz-Kompanie passes an assortment of headquarters vehicles. The crew has fabricated a tarp to help keep dust out of the gun port and the muzzle plug is in-place. Most self-propelled guns used canvas muzzle covers rather than plugs. Even through travel with the muzzle protected, standard procedure required the crew to visually inspecting the bore to ensure there were no obstructions before firing.

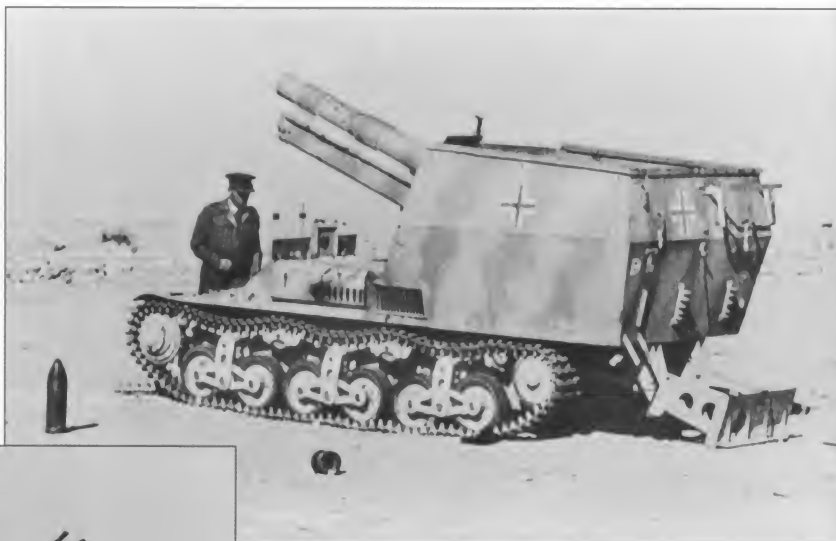
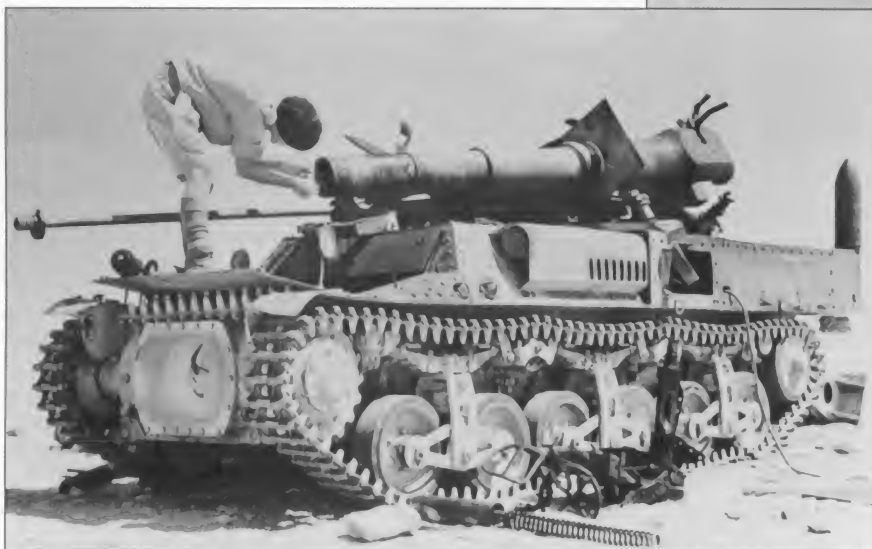
A British soldier measures the caliber of a 15cm Sd.Kfz.135/1 with its superstructure blown off, probably from propellant and some projectiles detonating. The blackened traversing mechanism rests on the ground by the middle set of bogie wheels. An unexploded high explosive projectile had been set on the vehicle's left rear. It was manned by a crew of four and could carry only eight rounds.

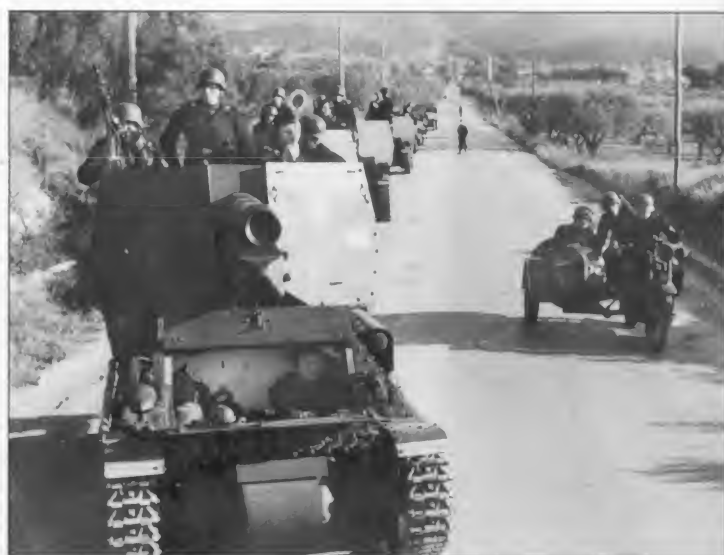
The driver's compartment of this Sd.Kfz.135/1 is open with its split shutters opening upward and downward. Note the 7.92mm MG-34 machine gun with an anti-aircraft sight mounted on the right front of its superstructure. From the front his vehicle can be confused with the more common 'Bison' I Sd.Kfz.101 mounting a 15cm infantry gun in its high, boxier superstructure.

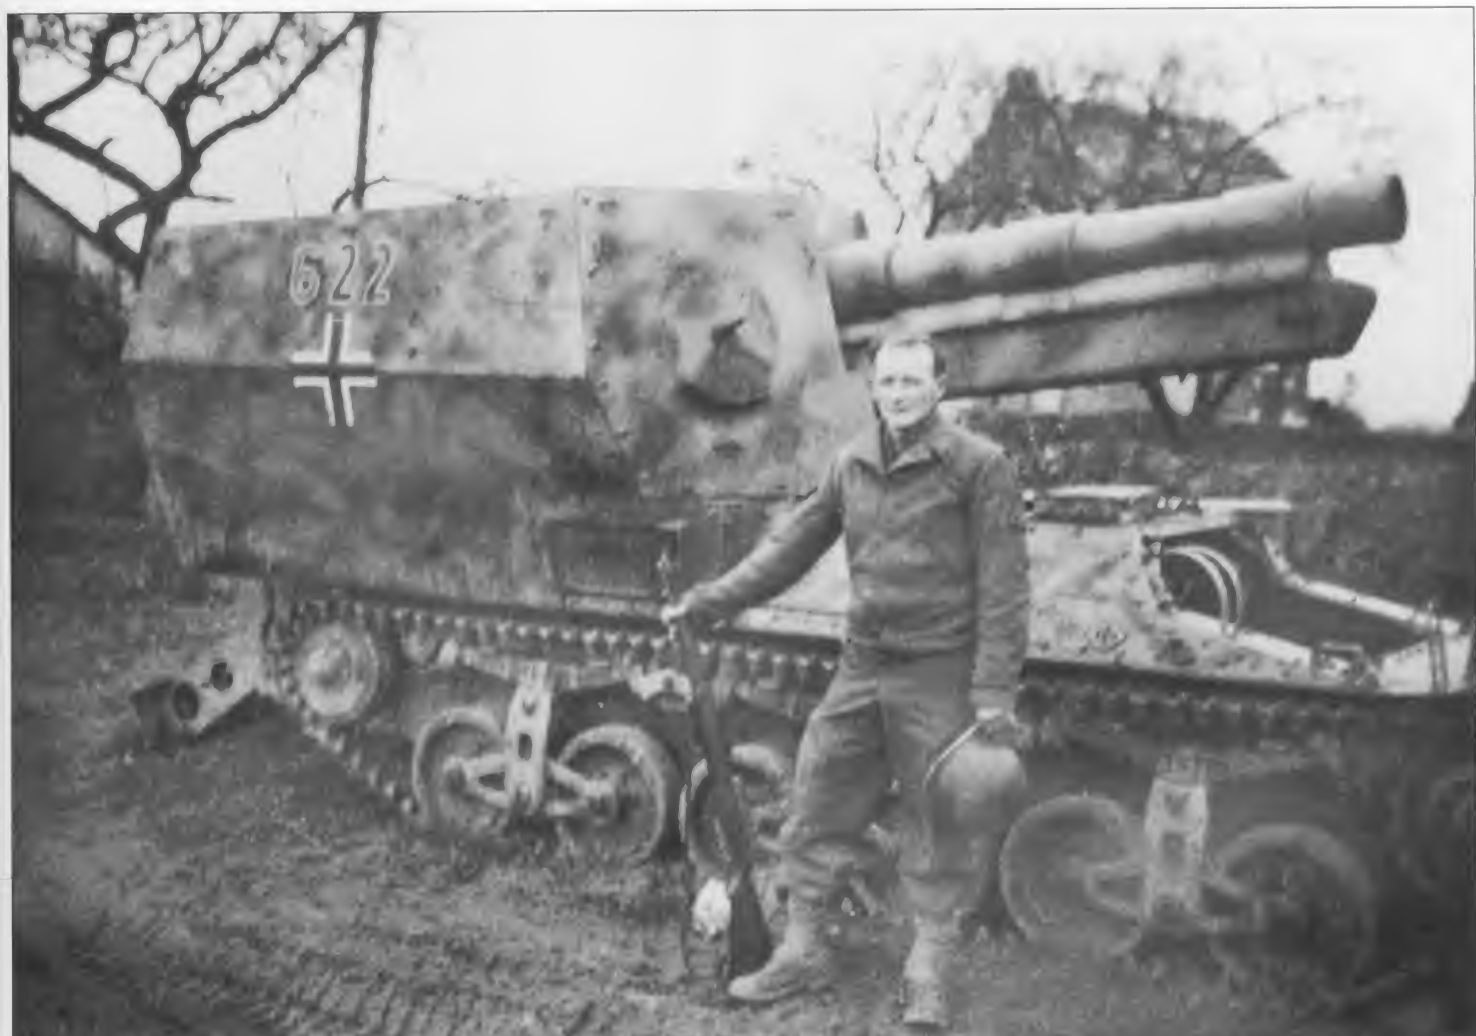
A small number of 15cm s.F.H.13/1 (Stf.) auf Geschützwagen Lorraine Schlepper (f) Sd.Kfz.135/1 self-propelled heavy field howitzers were built on French Lorraine tractor chassis. Initially, they were assigned to two heavy infantry gun regiments with six assigned to a battery. These two regiments were later disbanded and their guns distributed among the infantry and Panzer divisions in the west. The camouflage is probably olive green and red brown mottled over dark yellow. An American infantryman poses before this example in France, 1944.

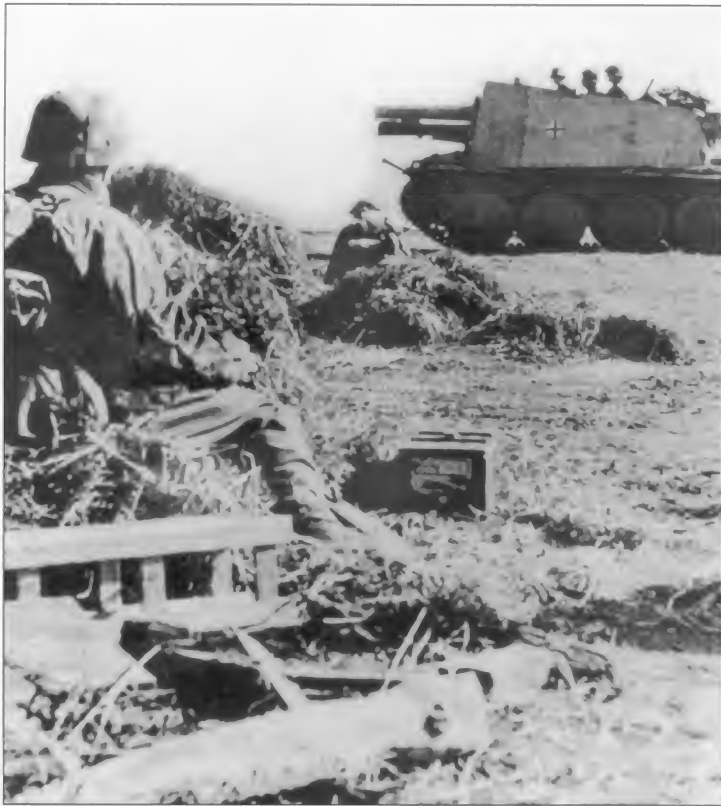
The 15cm s.I.G.33(Sf.) auf Pz.Kpfw.38(t) 'Grille' Ausf.H (Cricket), (Sd.Kfz.138/1) was built on the Pz.Kpfw.38(t) chassis. It mounted a 15cm s.I.G.33/1 L/12 infantry gun. Also incorrectly called a 'Bison', they were produced in limited numbers, but saw service in all theaters assigned to Panzergrenadier regiments. It had a crew of five and was provided an MG-34 carried in the gun compartment. This gun moves forward in support of Panzergrenadiers in Russia. This vehicle is a solid dark yellow without any camouflage over-painting.

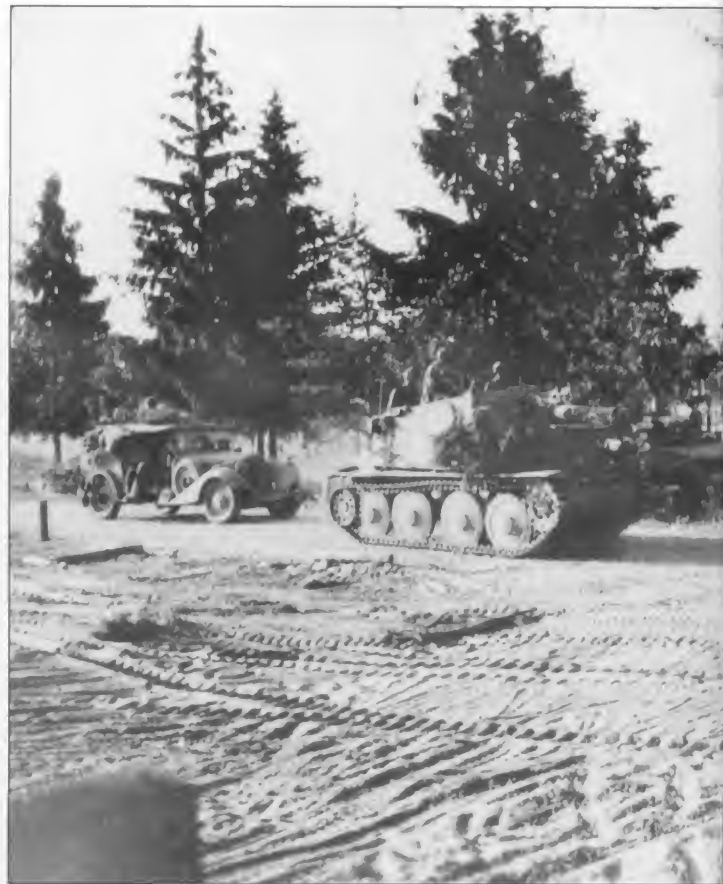
A 'Grille' Ausf.H from 4.Panzer-Division in Russia is followed by one of scores of types of light trucks employed by the Germans. So long as at least 150 vehicles of given type of vehicle were available and it was remotely useful for military service, they were commandeered and issued to rear service units.

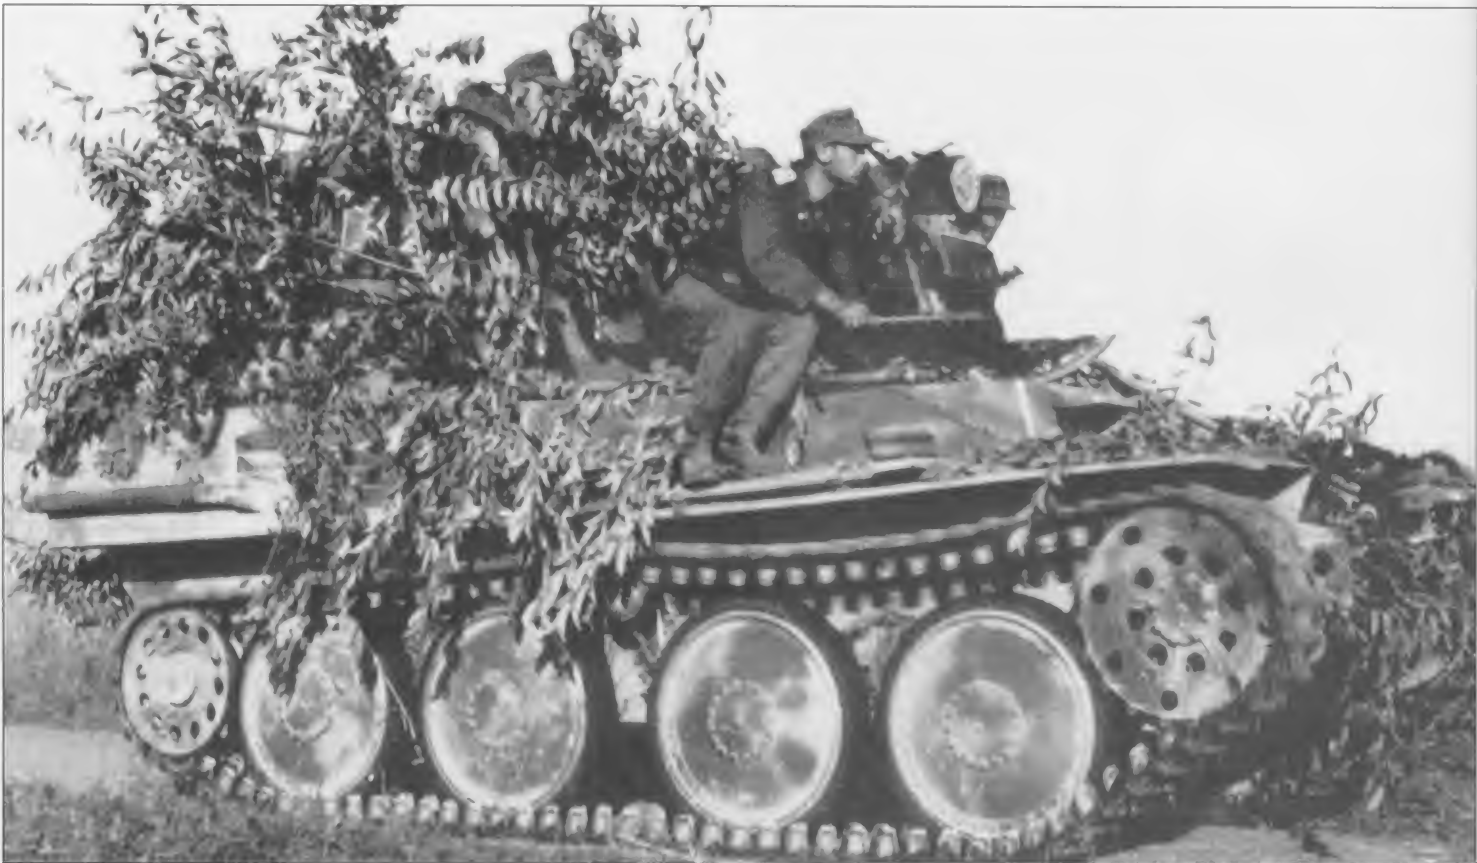
A heavily camouflaged 'Grille' Ausf.K rushes into action during the battle of Kursk, July 1943. This was a variant of the Marder III Sd.Kfz.138, which mounted a 7.62cm gun. The Sd.Kfz.138/1 Ausf.K mounted a 15cm s.F.H.33/1 heavy infantry gun and was of an entirely different design than the Sd.Kfz.138/1 Ausf.H, though both used the Czechoslovak Pz.Kpfw.38(t) chassis.

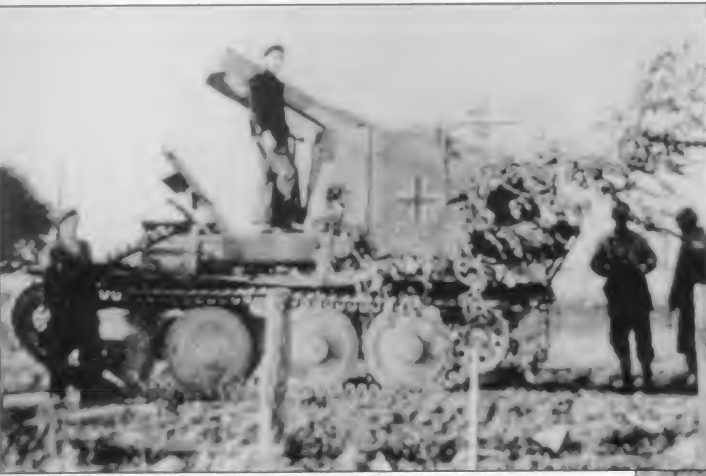
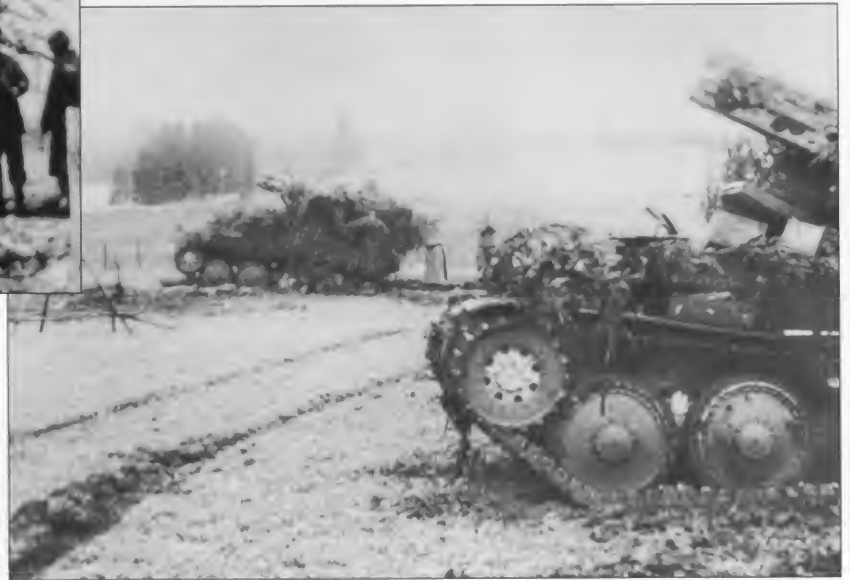
A pair of heavily camouflaged 'Grille' Ausf.K self-propelled guns occupy firing positions in a mist-shrouded field. The 15cm s.I.G.33 infantry gun could fire 5-7 rounds per minute. Both high explosive and smoke rounds were available. It had a crew of five.

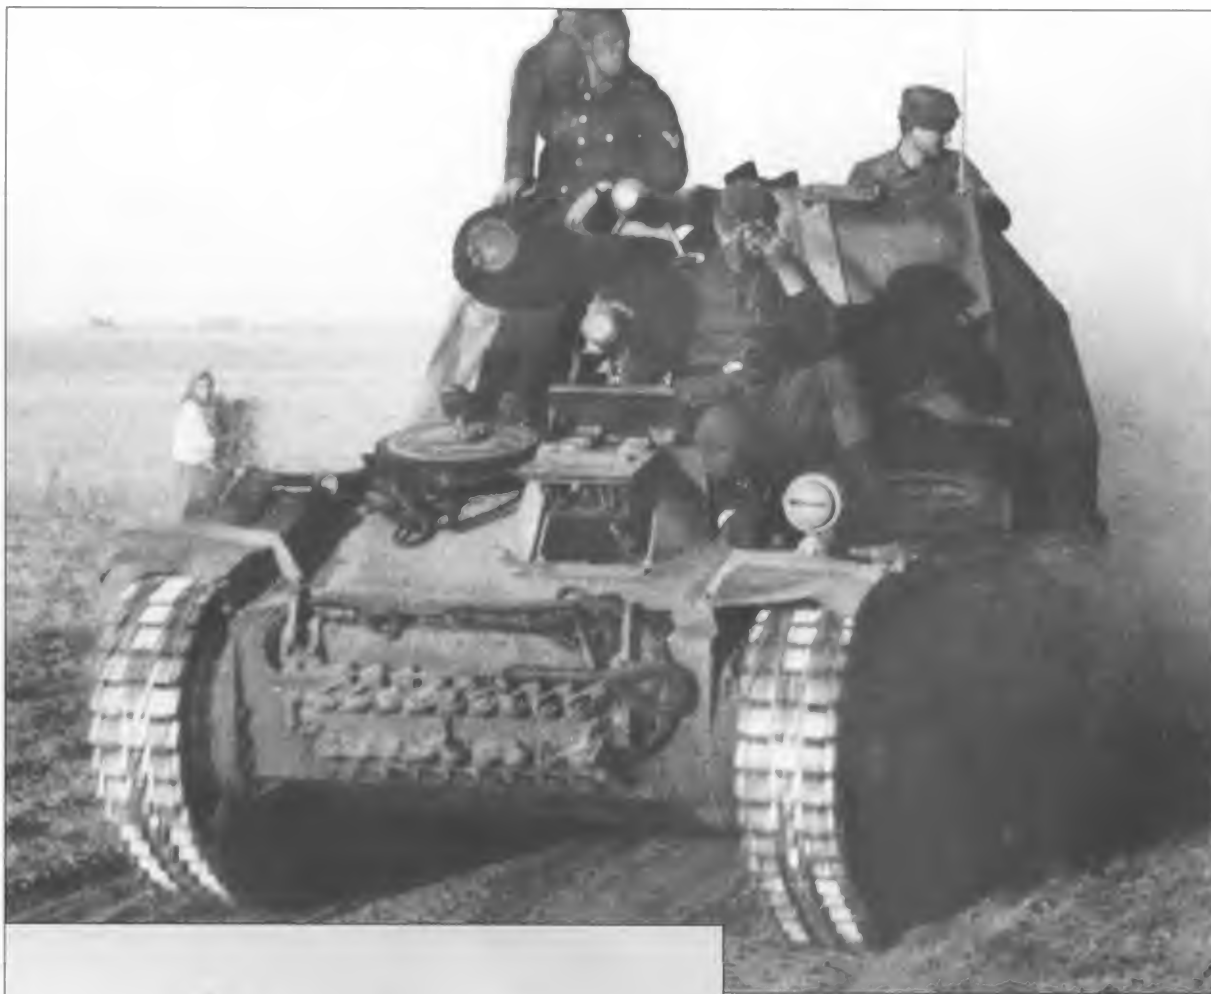
A 'Wespe' barrels down the road passing Russian peasants, who quickly learned that roads were for military traffic and civilians were to keep to the sides. Even weighing over 12 tons and considered overloaded for its Maybach 6 cylinder gasoline engine, a 'Wespe' could hit 25 miles per hour (40 kilometer per hour). Such high speeds were only undertaken when absolutely necessary though because of the rapid wear on engines, transmissions, tracks, and running gear.

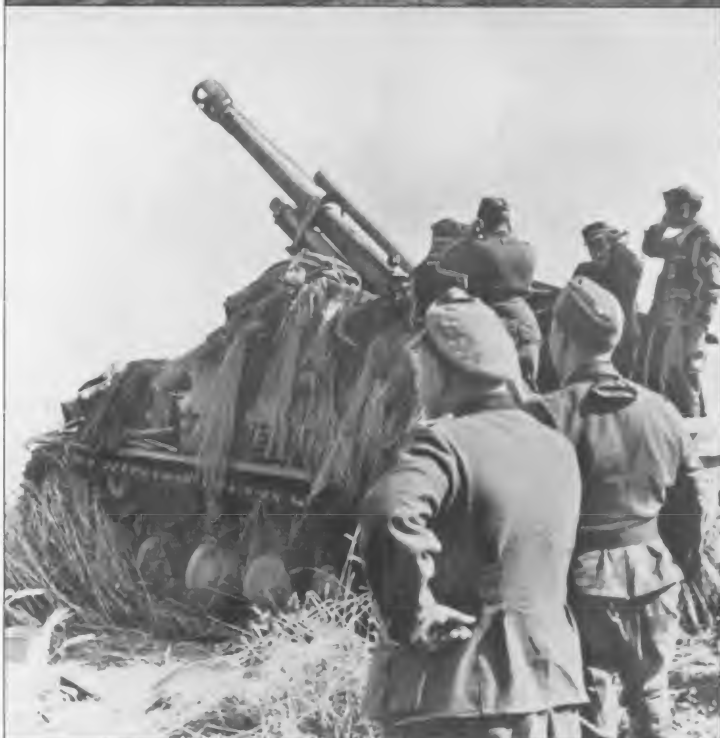
A 'Wespe' cracks out rounds at Soviet positions. The 10.5cm le.F.H.18/2 Fahrgestell auf Geschützwagen Pz.Kpfw.II or 'Wespe' (Wasp) was also known as the leichte Feldhaubitze 18/2 auf Fahrgestell Pz.Kpfw.II (Sf.) (Sd.Kfz.124). The 'Wespe' mounted a le.F.H.18/2, the same as used as towed artillery in divisional artillery regiments. The 'Wespe' was built on a Pz.Kpfw.II Ausf.F chassis modified by relocating the engine in a central position to allow space for the gun compartment. A total of 676 were built in 1943-44. This vehicle has been fairly well camouflaged with bundles of wheat. The oval object behind the neck of the foreground officer to the right is a leather binocular eyepiece cover used when the binoculars were slung around the neck and were not protected by its case. It was commonly slid on the strap out of the way behind the neck.

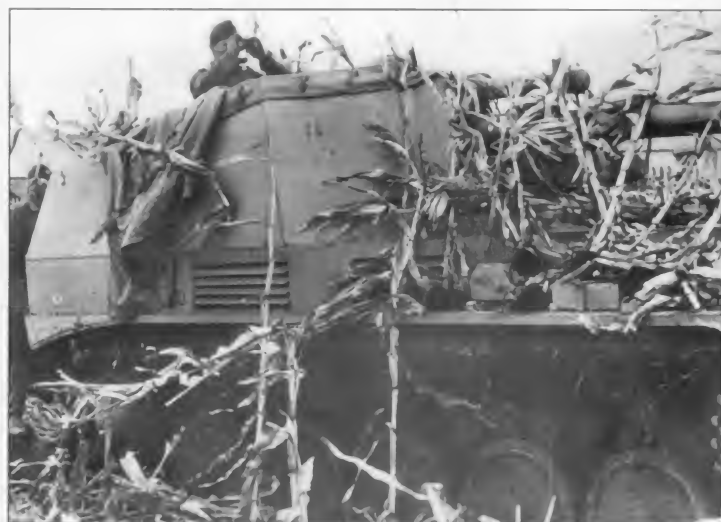
A Waffen-SS 'Wespe' takes up position in a Russian cornfield, November 1943. Note the form-fitting canvas gun compartment cover. The 'Wespe' had a crew of five protected by 10mm armor on the gun compartment's superstructure. The howitzer had a 17-degree left and right traverse and a 42-degree elevation. While the crew was armed with Kar.98k carbines, they were also provided an MG-34 machine gun, which was occasionally mounted atop the gun compartment on the right side, and a 9mm MP-38 or MP-40 machine pistol (submachine gun).

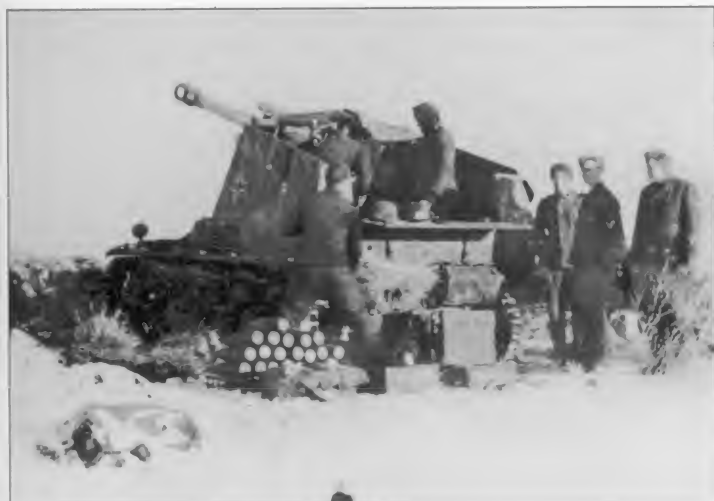
Though it is winter, the 'Wespe' has retained its normal camouflage. Judging by the relatively light clothing the crew is wearing; this may be elsewhere in a milder climate than deep in Russia. The armored 'Wespe' protected the crew from some degree of counterbattery fire, but its mobility was more advantageous to its survival. The full-tracked chassis allowed it to keep better pace with the panzers they supported and allowed them to occupy firing positions that may have been unreachable by even half-track-towed artillery. Ammunition included high explosive, high explosive-incendiary, and smoke. Additional ammunition was carried in the Munitions St. auf Fgst. Pz.Kpfw.II, or Munitionsschlepper 'Wespe', full-tracked carrier, two per battery. Only 159 of these were built and most 'Wespe' batteries were supported by 5-tonne Sd.Kfz.6 half-tracks or simply cargo trucks.

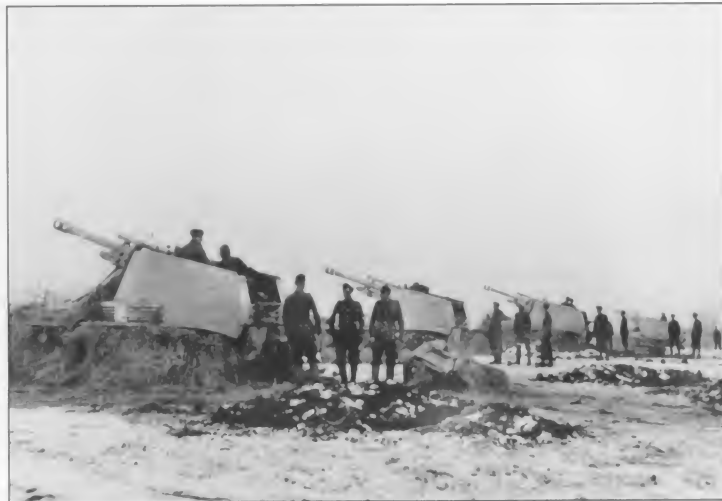
A 'Wespe' battery in a close firing position. While six guns were authorized per battery, it was not uncommon for fewer to be available. These guns have been whitewashed. Slit trenches for the crews have been dug immediately behind each gun. There appears to be little concern for Soviet counterbattery fire since the guns are positioned so closely together and in a neat formation. The tight formation also allows the guns to deliver a close concentration on a small target without having to adjust the angle of each guns' fire in a more dispersed formation.

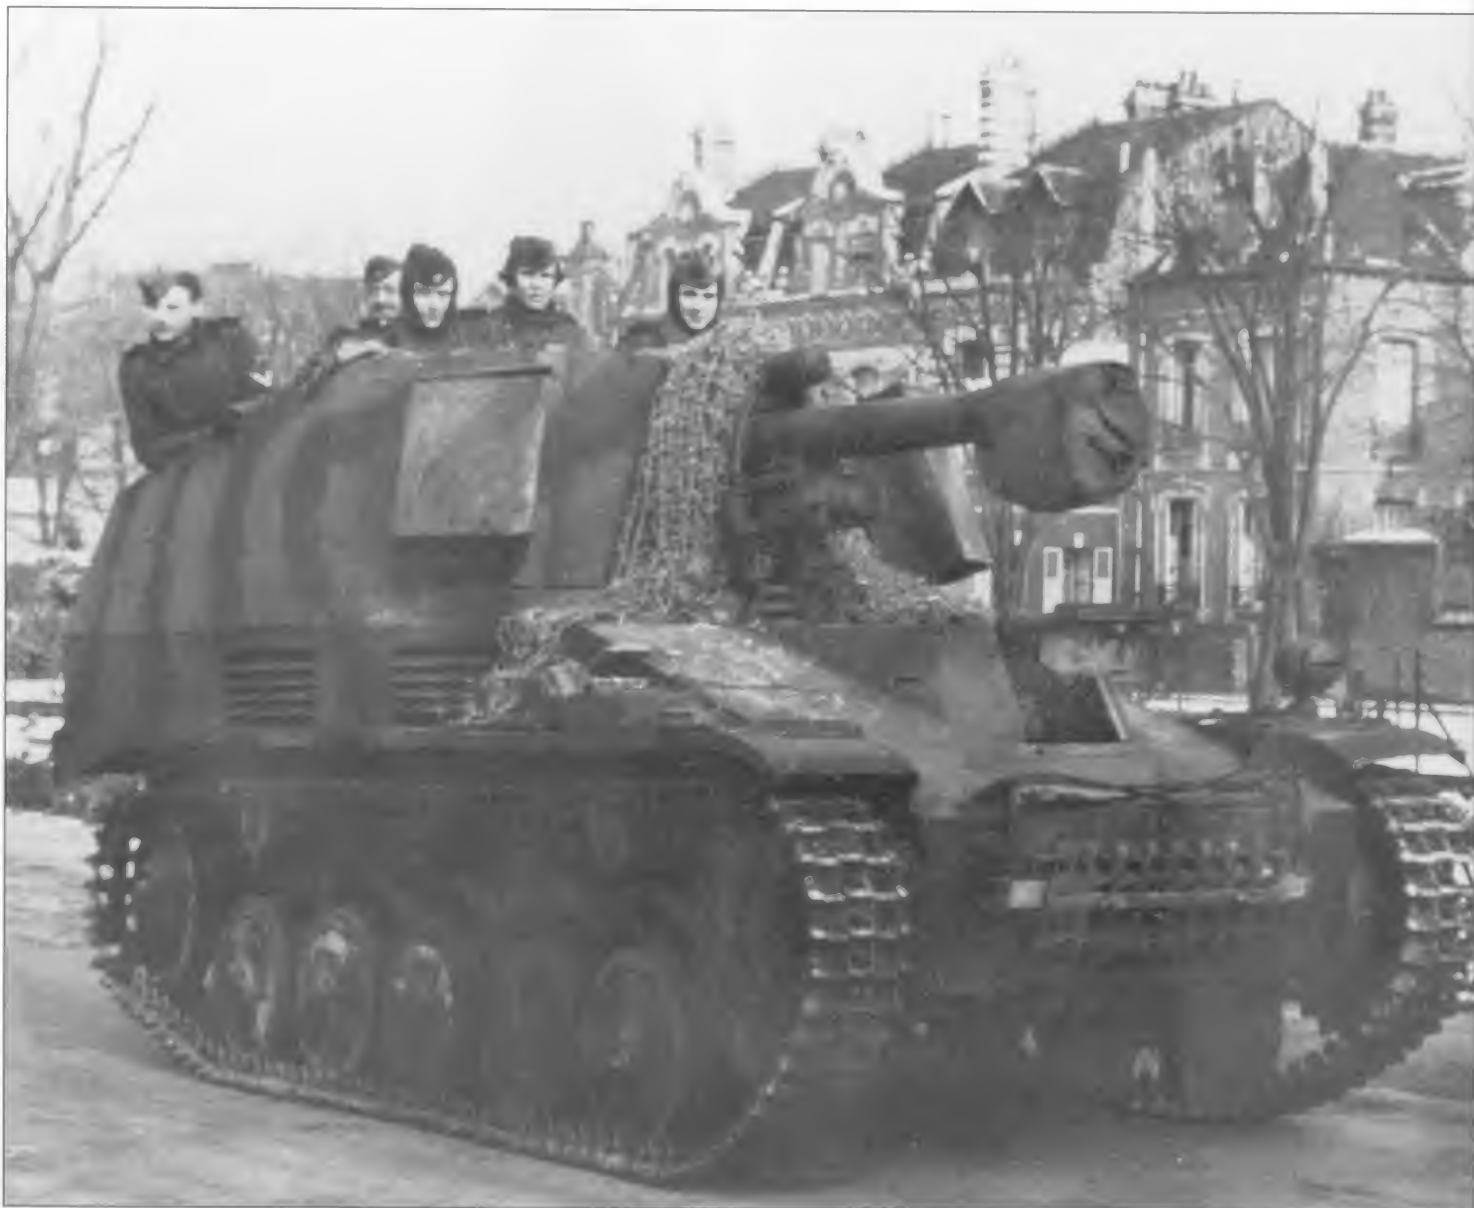
Obviously a winter scene, this 'Wespe' rumbles through a French town. This camouflage pattern appears to be dark green over the dark gray base. While the bands are of somewhat irregular form, their even spacing and width makes this a less than effective pattern. A camouflage net is draped over the howitzer barrel allowing it to be pulled forward and rearward to quickly cover the vehicle. The louvered vents on the hull sides are for the centrally mounted engine's ventilation.

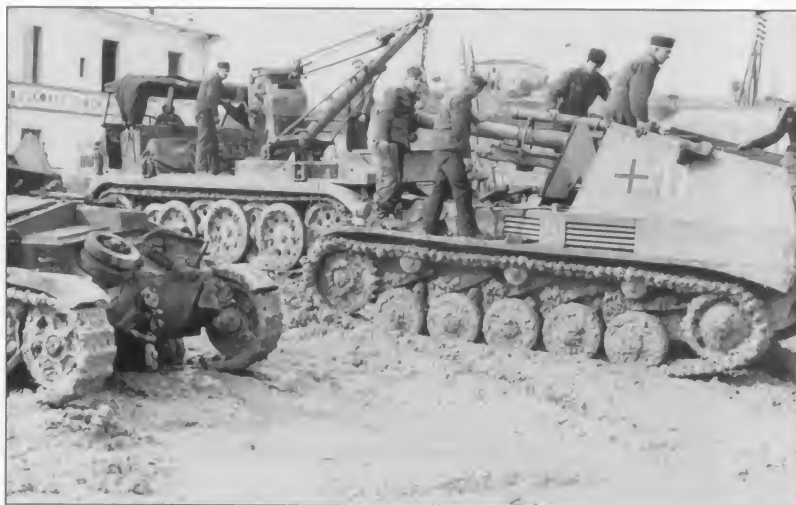
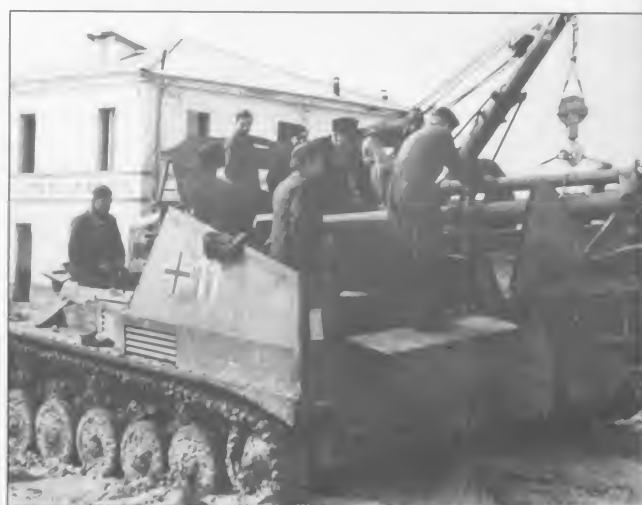
The motor park of an artillery battalion's workshop company would immediately be churned into a mud bath after even a light rain as this scene in Italy. Here a 'Wespe' crew replaces the worn-out 10.5cm howitzer. A Sd.Kfz.9/1 heavy half-track mounting a 6-ton Bilstein crane assists. The 18-ton capacity half-track, without crane, was used as a prime mover for heavy artillery and engineer equipment. Tactical number systems for self-propelled artillery were different than that used by tank units. The white "11" identifies Number 1 gun, 1st Battery. The rear end of the vehicle to the left is either an Italian Semovente da 75/18 assault gun or a M13/40 medium tank.

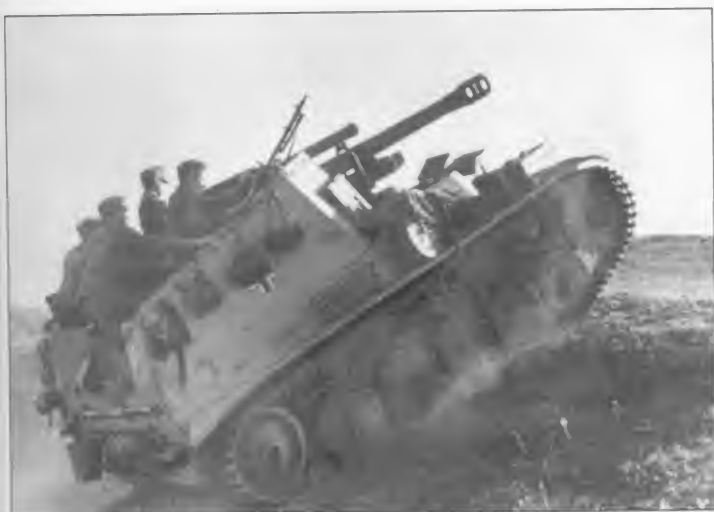
A 'Wespe', its MG-34 mounted, churns its way up a ravine side. The crew has slung their bread bags (containing rations and small personal items) on a wire attached to the superstructure's side. The crewman at the left wears radio headphones. This particular vehicle is gun "A" of a battery.

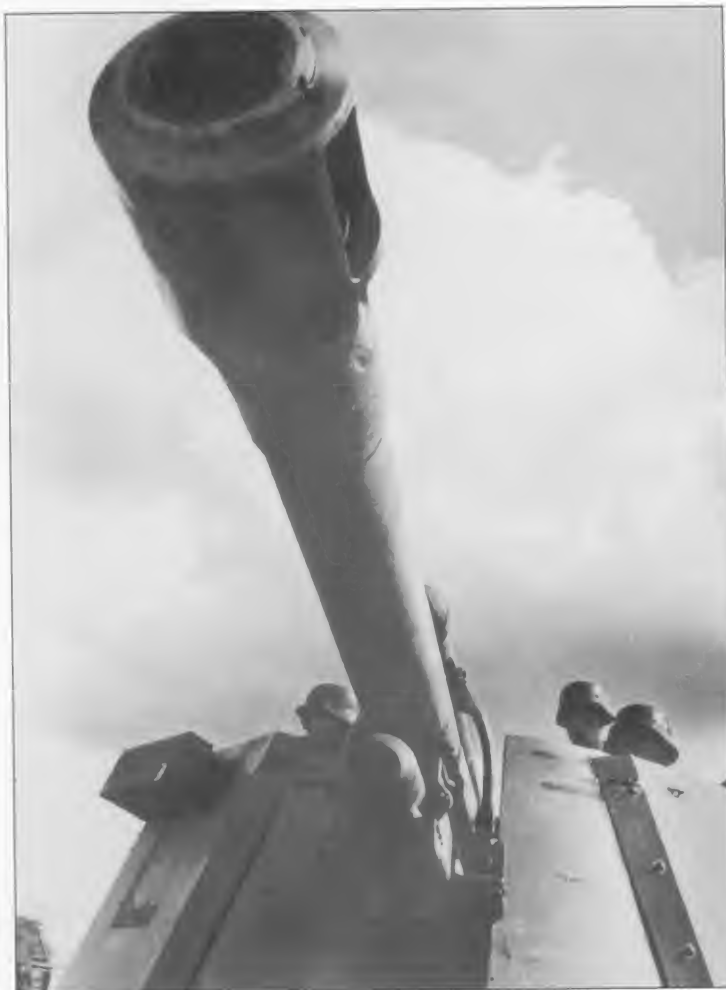
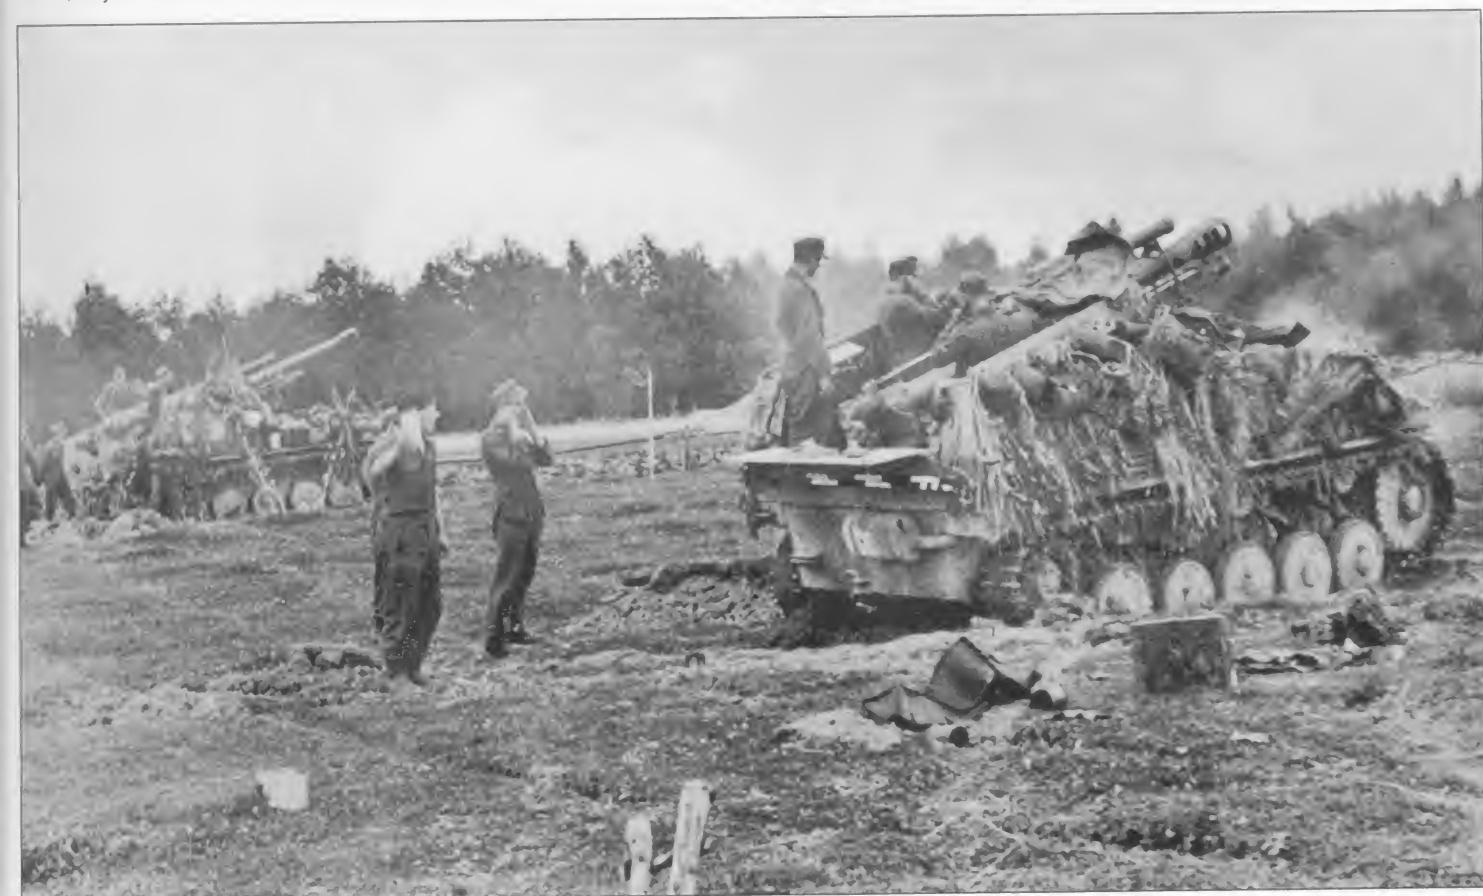
While camouflaging vegetation obscure these two 'Wespe', the lowered tailgate provides a view of the gun compartment with the howitzer in recoil. Note the red and white striped aiming stake poles stowed beneath the drop-tailgate. These are positioned forward of the gun to provide an azimuth reference point for indirect fire. An aiming stake can be seen between the two guns. Soviet Union, August 1944.

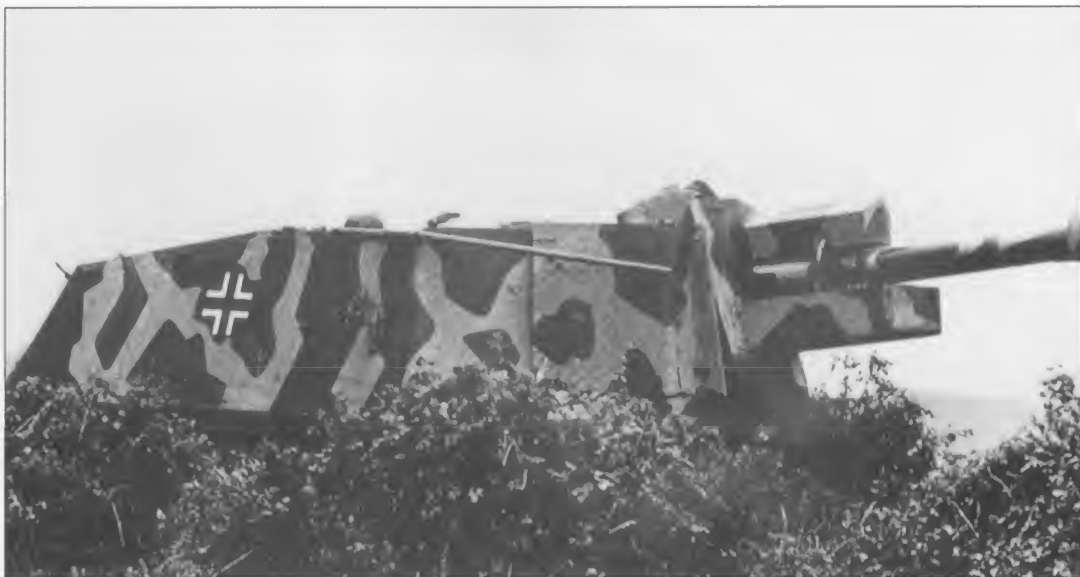
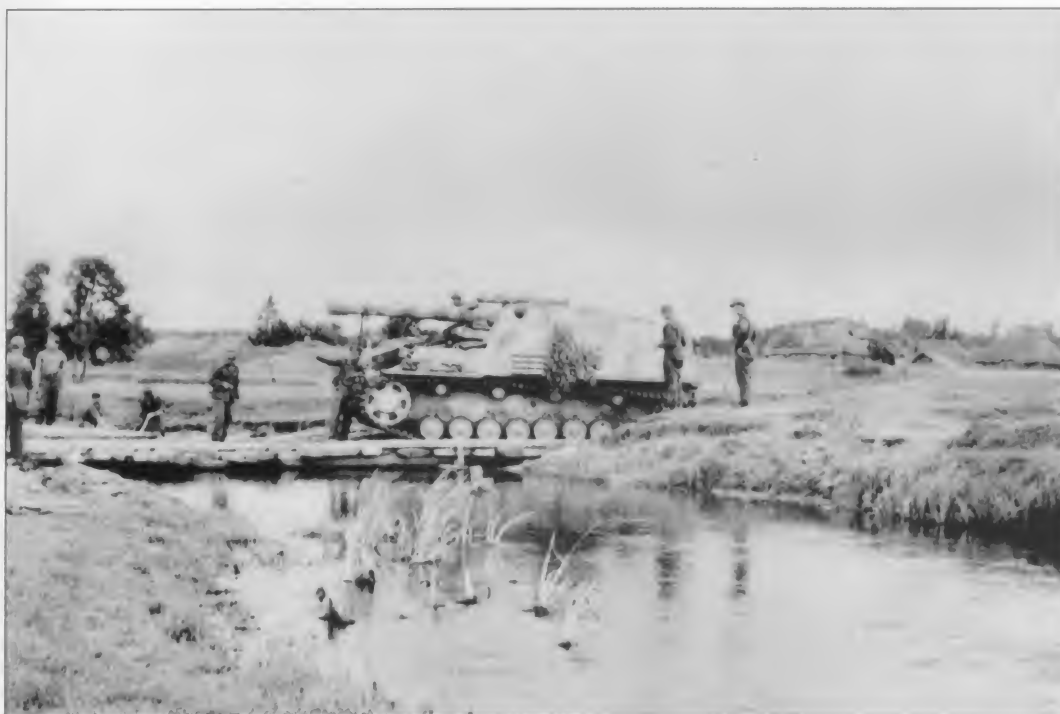
The 15cm Schwere Panzerhaubitze auf Geschützwagen III/IV (Sf.), or Sd.Kfz.165, was commonly known as the 'Hummel' (Bumblebee). This vehicle was built on a hybrid chassis employing features and components of the Pz.Kpfw.III Ausf.J (driving and steering mechanism) and Pz.Kpfw.IV Ausf.F (hull, suspension, engine, and cooling system). The engine was repositioned in the center to allow space for the gun compartment. This 'Hummel' crosses a simple, hastily erected bridge. The stream is not too wide, but while full-tracked vehicles are often thought of as able to cross minor obstacles, a stream such as this can easily halt such a vehicle. The below water stream banks may be too steep and even if shallow the saturated bottom too deep with mud and silt to allow the vehicle passage. It is evident that the pioneers are confident of their work as some remain on the timber pontoon bridge as the 25.2-ton (22,860-kilogram) vehicle eases over the rain-swollen stream.

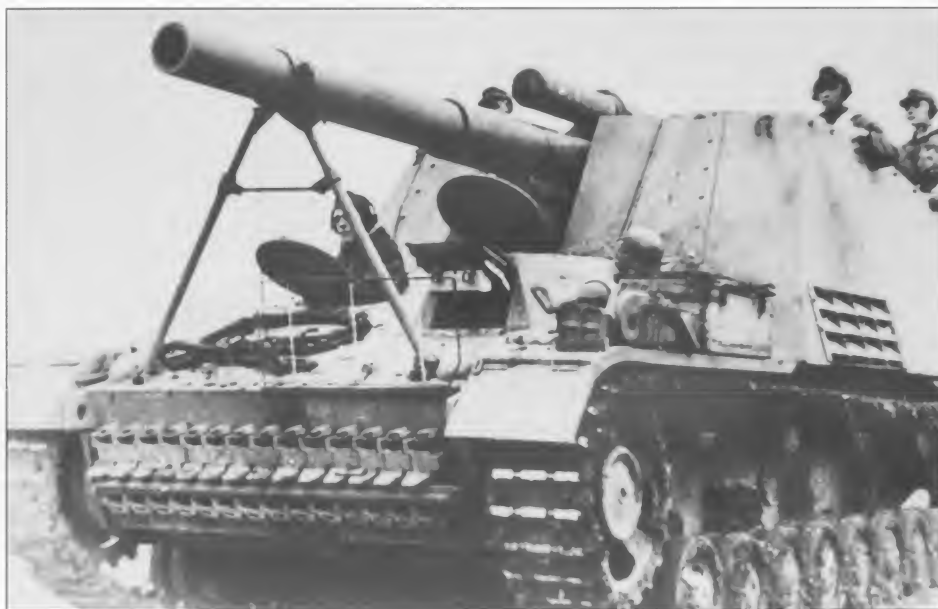
A 'Hummel' battery in firing position. The near vehicle has a tarp draped over the side to help break up its profile. The next gun further back has planks laid against its side for the same purpose. In the foreground are wicker shipping containers for the 94.6-pound (42.9-kilogram) high explosive projectiles. Artillerymen referred to the containers as a Koffer (suitcase). The disc-like object in the right foreground is the bottom side of a Tellermine. Artillery units would plant antitank mines on armor approaches into their area if they intended to occupy the position for sometime.

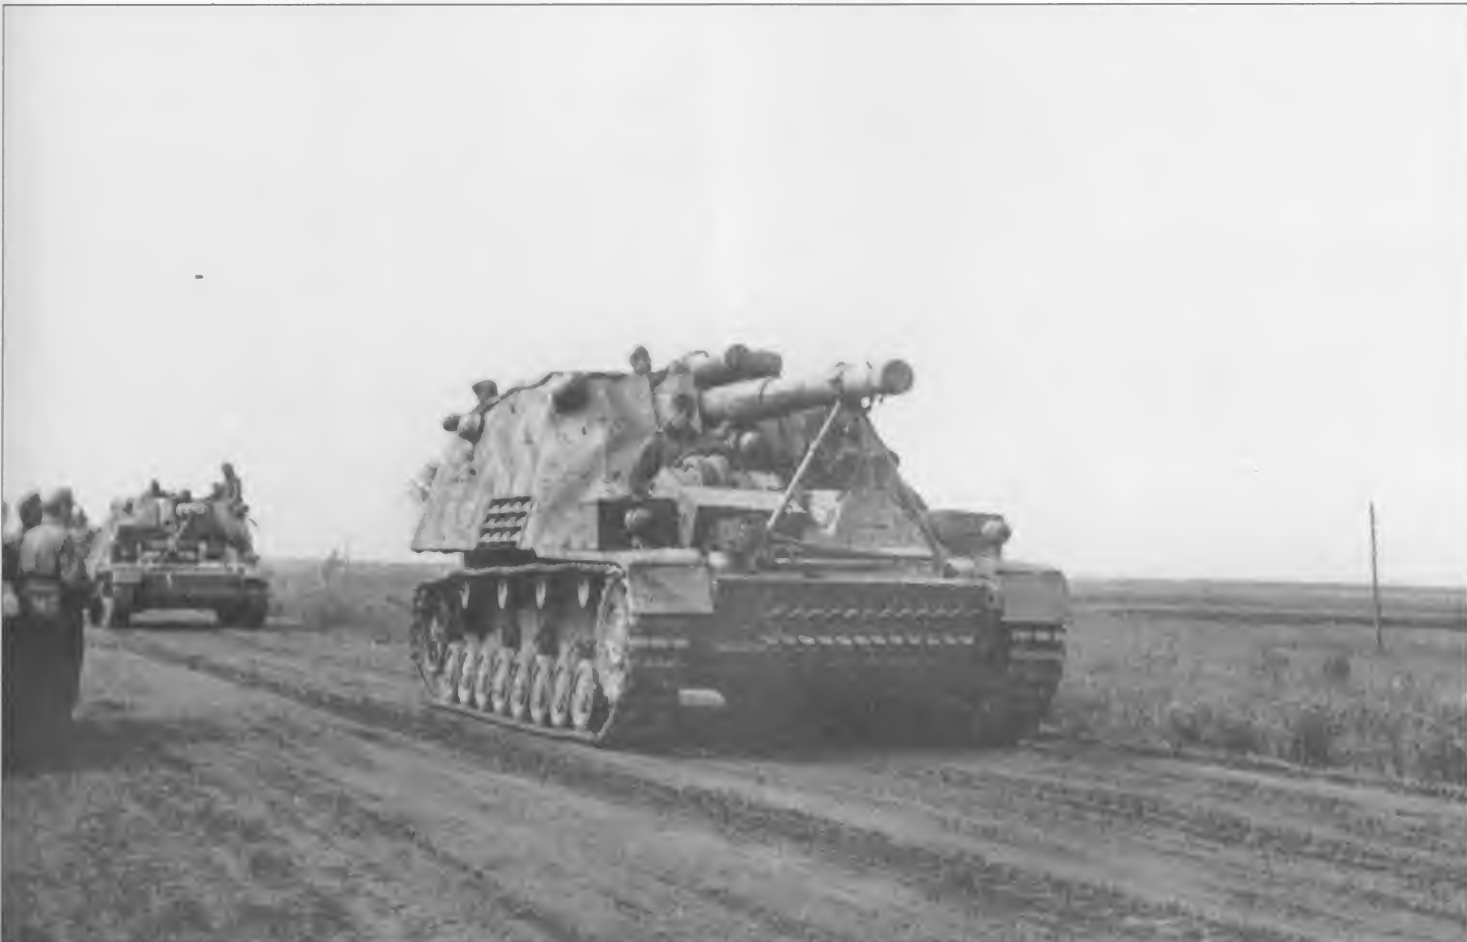
A battery of 'Hummels' move eastward deeper into the Soviet Union. For its day, even though it was considered a substitute weapon, it was an impressive and modern appearing self-propelled artillery piece. Plans were underway to develop both purpose-designed 10.5cm and 15cm self-propelled howitzers, but this effort was never completed.
